DEPARTMENT OF TRANSPORTATION

Contract #: 04-0120F4Cty: SF/ALA Rte: 80 PM: 13.2/13.9File #: 69.28**WELDING INSPECTION REPORT****Resident Engineer:**Pursell, Gary**Address:** 333 Burma Road**City:** Oakland, CA 94607**Report No:** WIR-016909**Date Inspected:** 31-Jul-2010**Project Name:** SAS Superstructure**OSM Arrival Time:** 700**Prime Contractor:** American Bridge/Fluor Enterprises, a JV**OSM Departure Time:** 1900**Contractor:** Zhenhua Port Machinery Company, Ltd (ZPMC), Changxing Island **Location:** Shanghai, China**CWI Name:** Gong Wai**CWI Present:** Yes No**Inspected CWI report:** Yes No N/A**Rod Oven in Use:** Yes No N/A**Electrode to specification:** Yes No N/A**Weld Procedures Followed:** Yes No N/A**Qualified Welders:** Yes No N/A**Verified Joint Fit-up:** Yes No N/A**Approved Drawings:** Yes No N/A**Approved WPS:** Yes No N/A**Delayed / Cancelled:** Yes No N/A**Bridge No:** 34-0006**Component:** OBG COMPONENT**Summary of Items Observed:**

In process Inspection

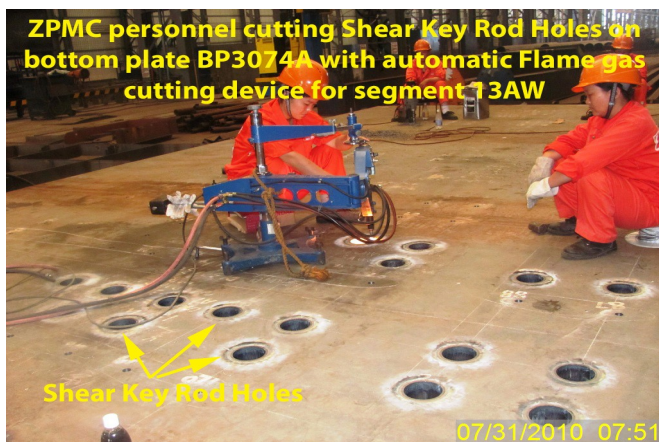
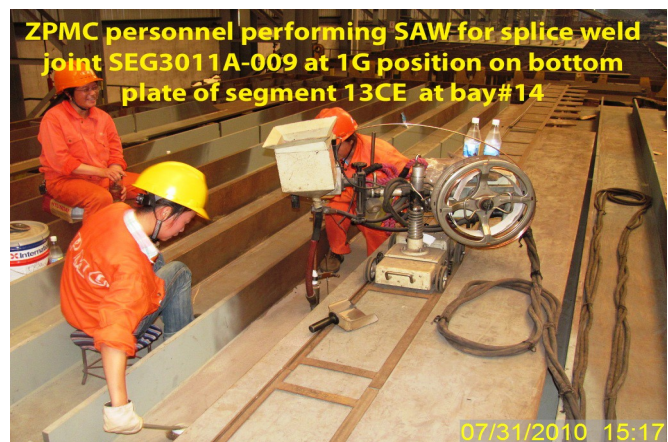
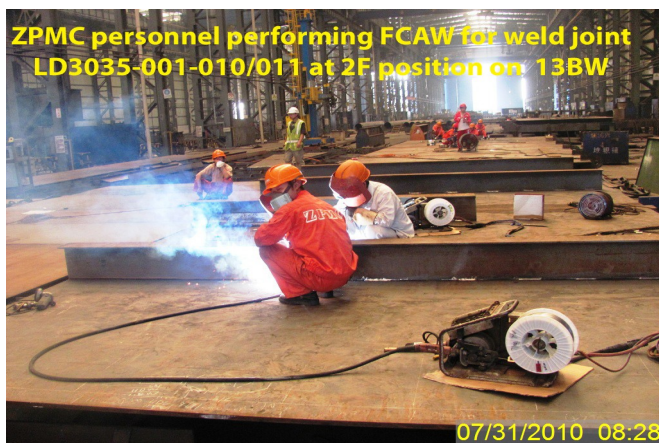
SAW in the 1G position for the OBG Segment 13CE, weld No. SEG3011A-009. The welder is identified as #044771. ZPMC QC is identified as Mr. Zhang Ling. The welding variables recorded by QC appear to comply with WPS-B-T-2221-B-L2c-S-2.

FCAW in the 2F position for the OBG Segment 13BW Longitudinal Diaphragm to stiffener, weld No. LD3035-001-010/011. The welders are identified as #201583/#040344. ZPMC QC is identified as Mr. Xin Chun Hui. The welding variables recorded by QC appear to comply with WPS-B-T-2132.

During random visual inspection at bay 16 the QA Inspector observed ZPMC personnel cutting Shear Key Rod Holes (100mm diameter) on bottom plate BP3074A with automatic Flame gas cutting device for segment 13AW.

This Quality Assurance (QA) Inspector performed random visual inspection of OBG segment 10BW internal side panel, floor beam and bottom panel surfaces after grit blasting in between panel point PP90 to PP91.5. Areas that marked for repair were recorded for future repair. Areas requiring additional grinding were marked by QA and repaired by ZPMC personnel.
